## Evita 4

### Technical Service Bulletin # 29

**Re:** Product improvement for all units before S/N ARNB-0070  
(Service Pack 1)

**Update:** May 22, 2000

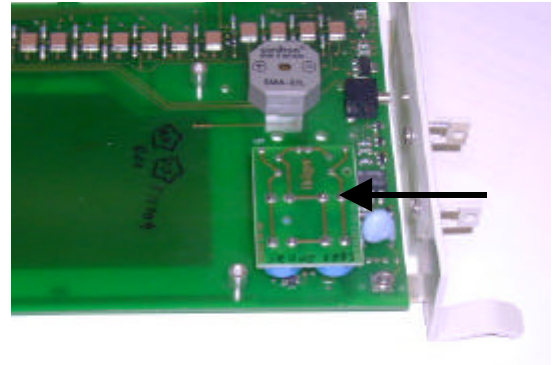
- The CO2 Carrier PCB P/N 83 06 611 is modified with the piggy back board "SuperGold PCB". The B-side of this board is labeled with 83 09 218.

- The change status of the CO2 Carrier PCB P/N 83 06 611 is 9.2 or higher (sticker with 83 06 611 - 9.2).

**Solution:** Installation of Kit Service Pack 1.
